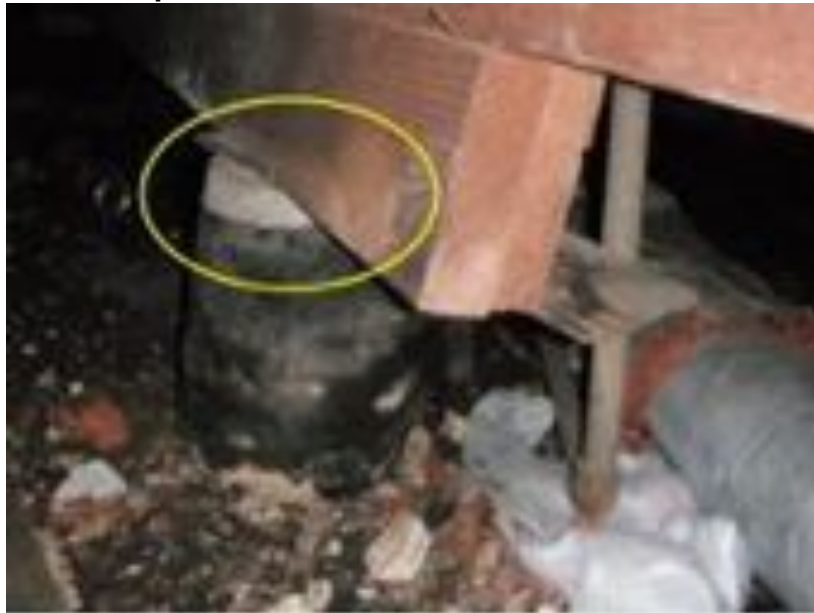
Concrete pier should not come into direct contact with wood

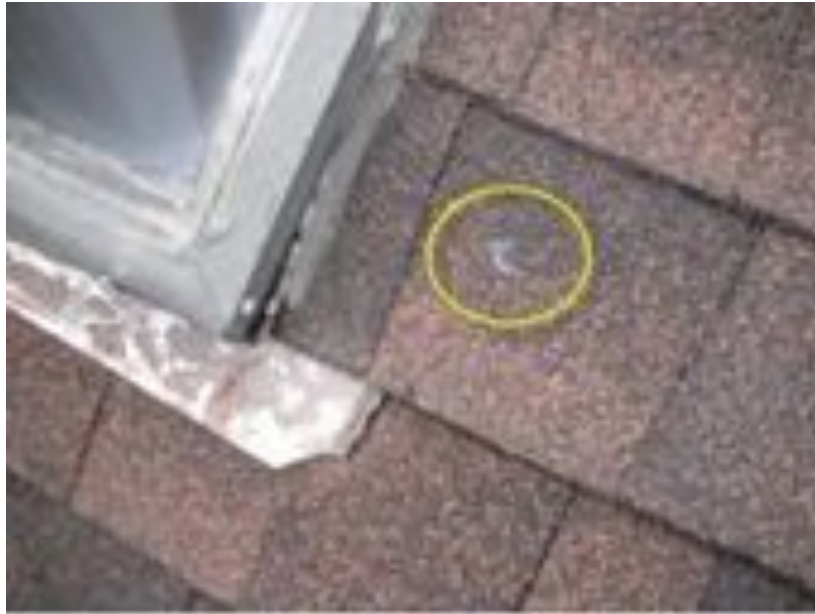
Damaged shingle at rear elevation to the left of skylight

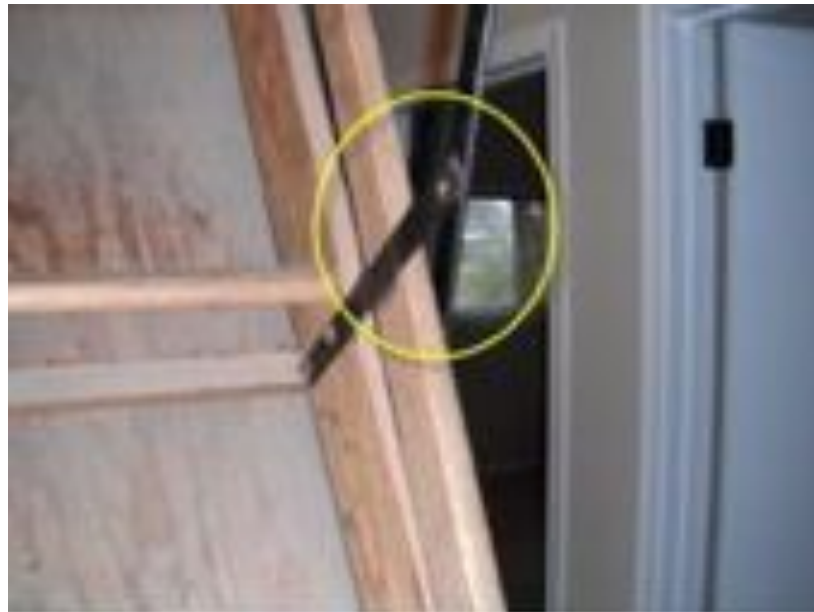
Broken attic ladder safety rail

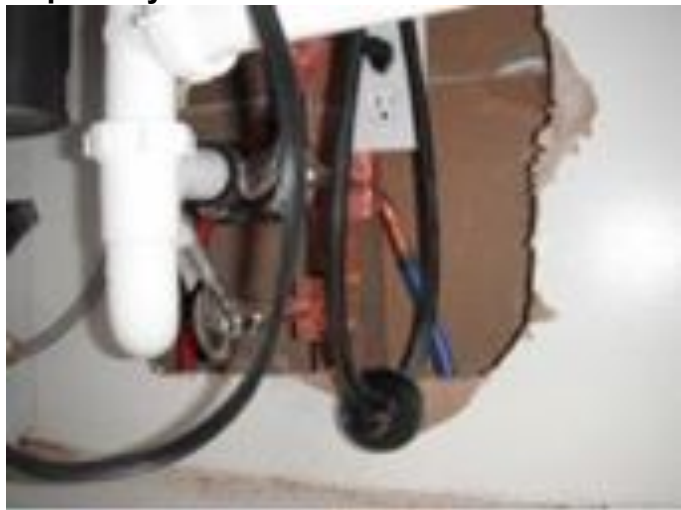
Repair dry wall under kitchen sink

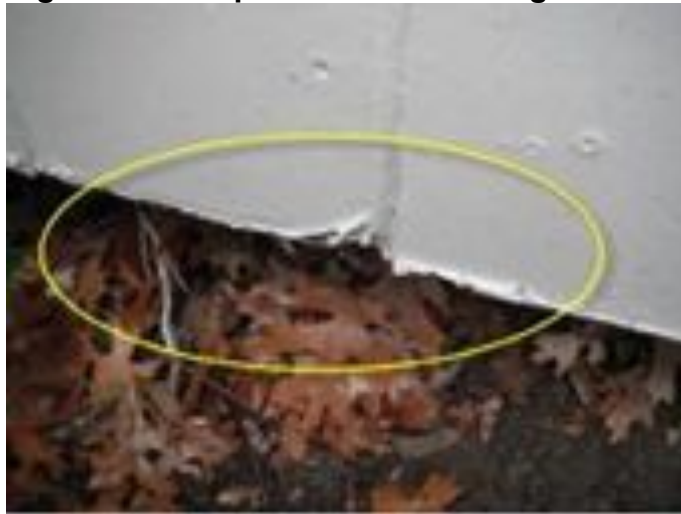
Sighs of water penetration at siding on left elevation

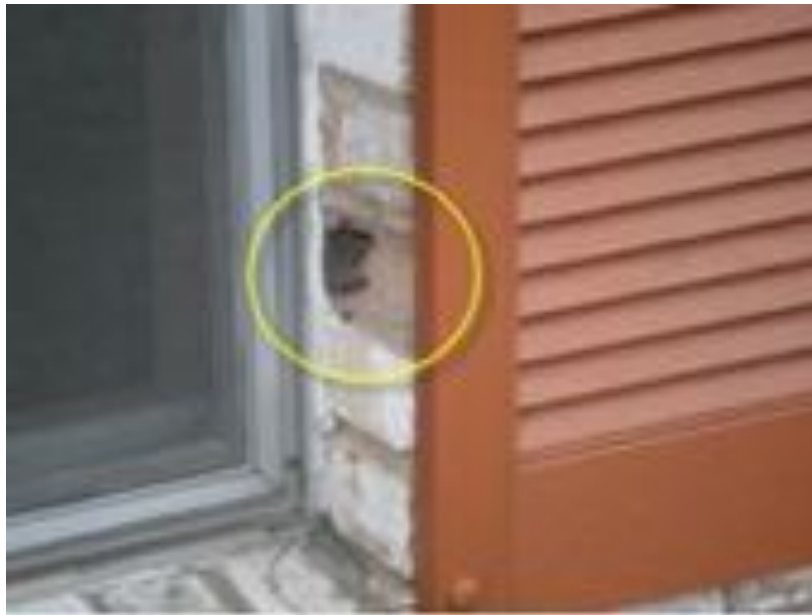
Repair wall at window on front left elevation

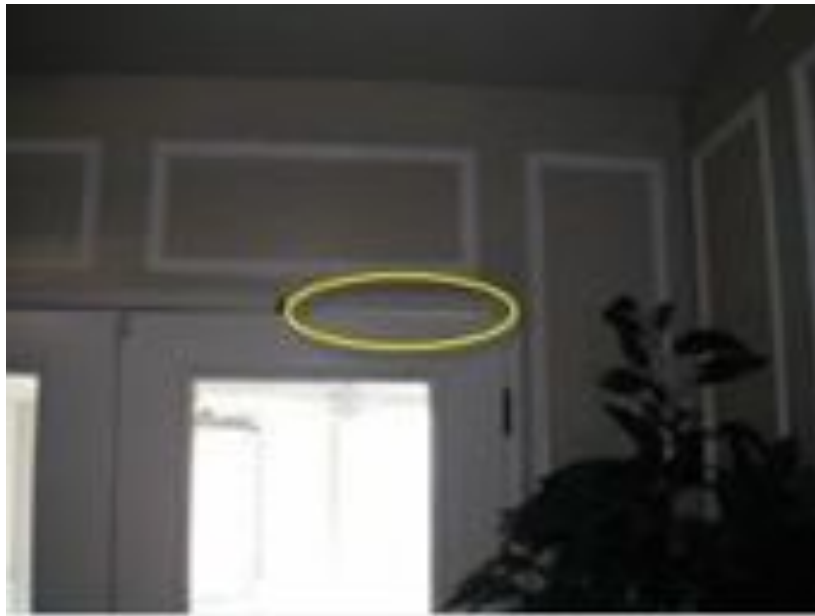
Door weather seal missing

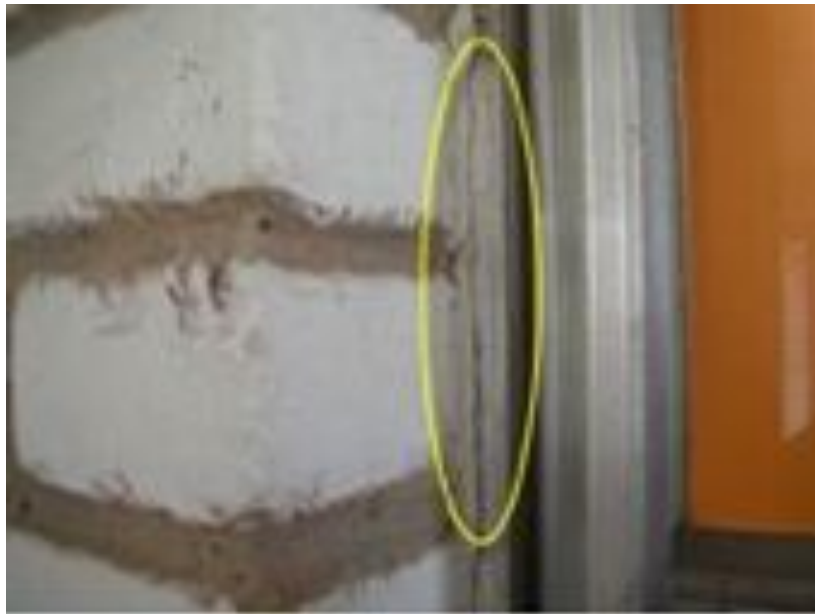
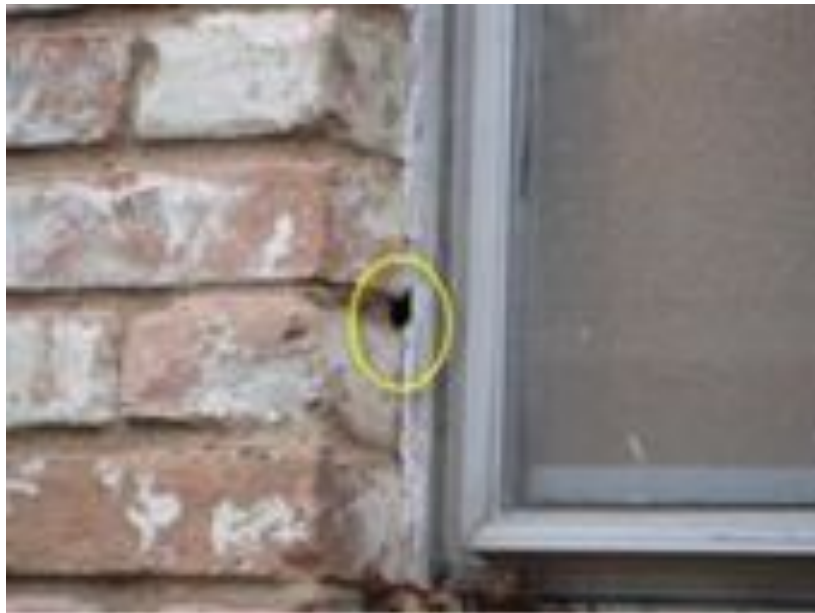
- Caulking weathered and cracked at all windows around the house

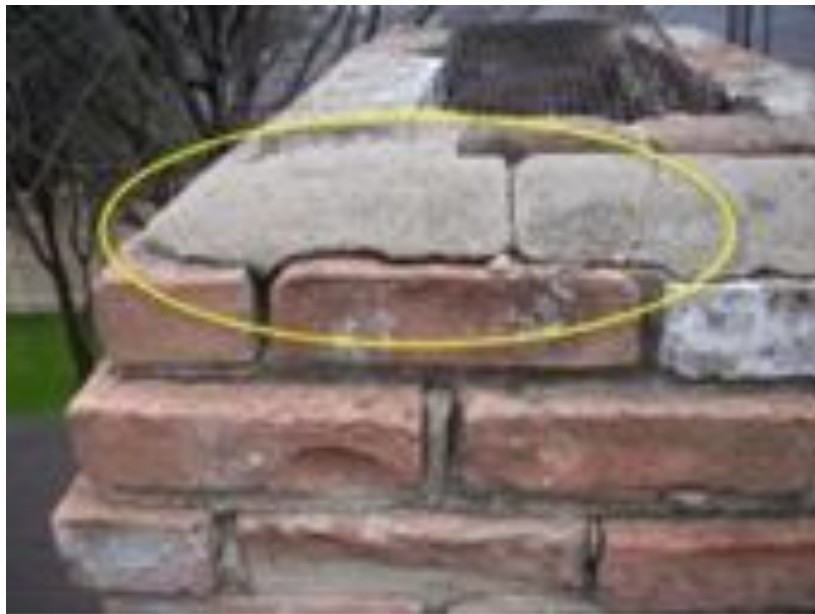
Cracked coping will lead to water penetration into the stack

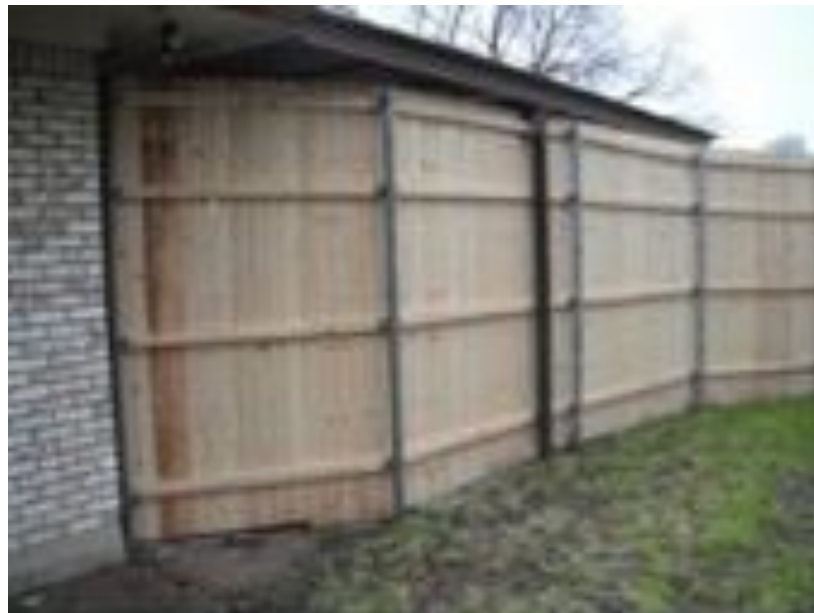
No egress from the back yard possible, a gate should be installed to allow escape from the rear yard in the event of a house fire

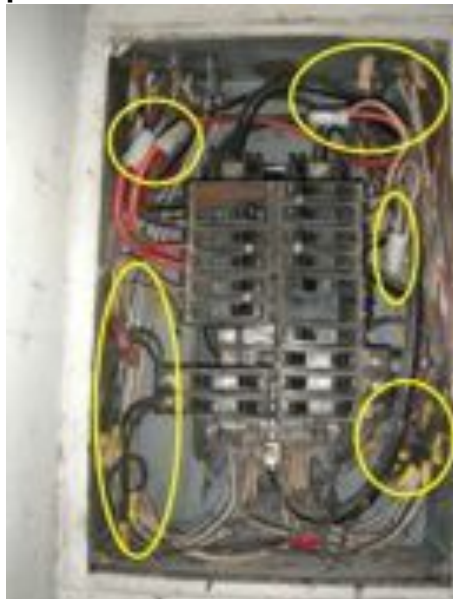
To many Pig Tailed Connections and additional circuits added which may be overloading the panel? I recommend that the opinion of a professional electrician is sort as to the safety of the service panel

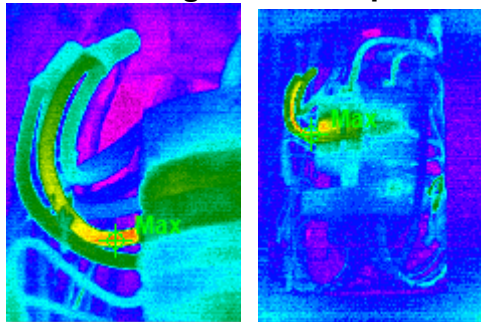
Over heating circuits in panel

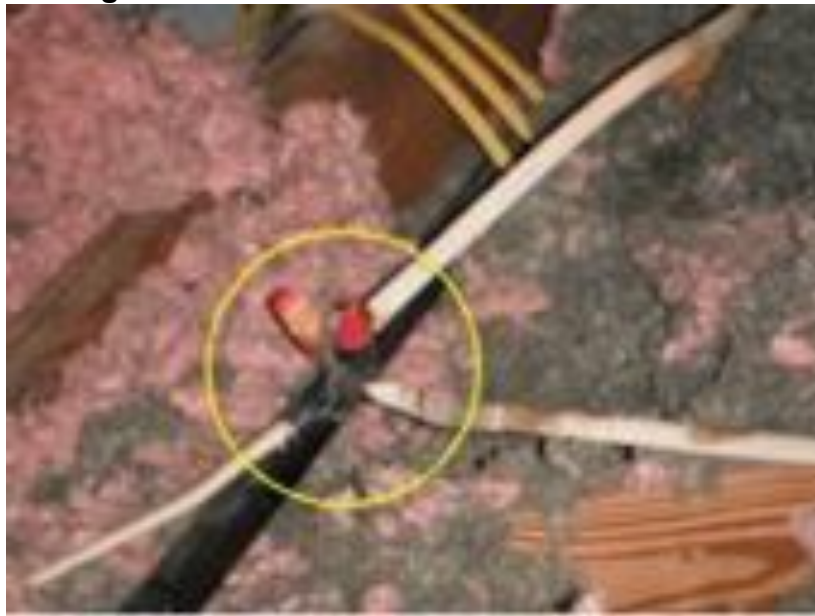
Dangerous splicing of conductors as shown here can lead to over heating and a fire.

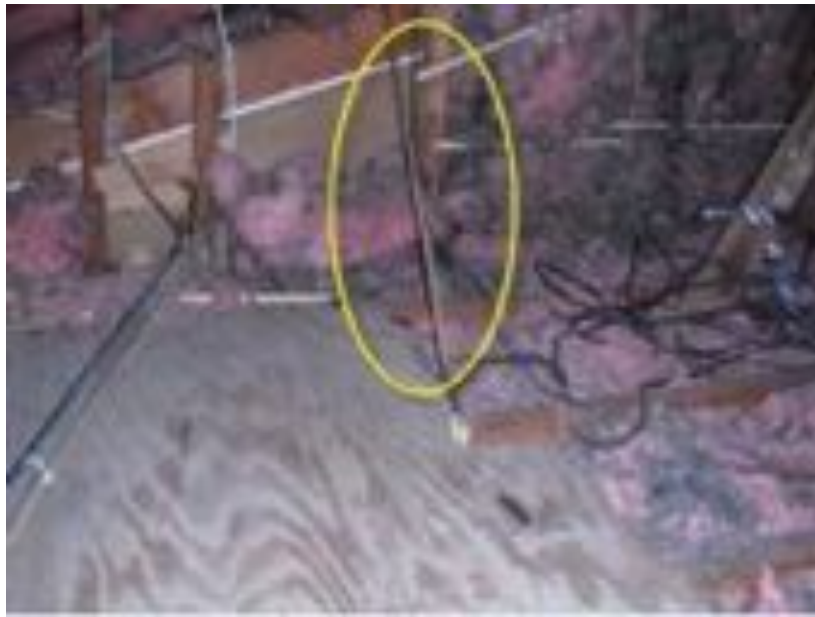
The ROMEX cable shown here is stretched and this can lead to the conductors thinning and then unable to carry their prescribe electrical load

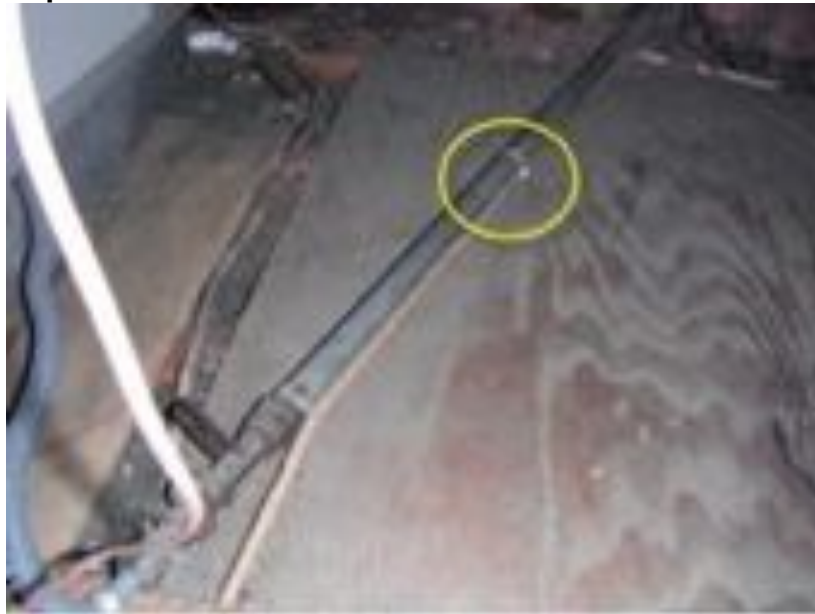
Gas lines and ROMEX cables must not be run together but separated to prevent contact

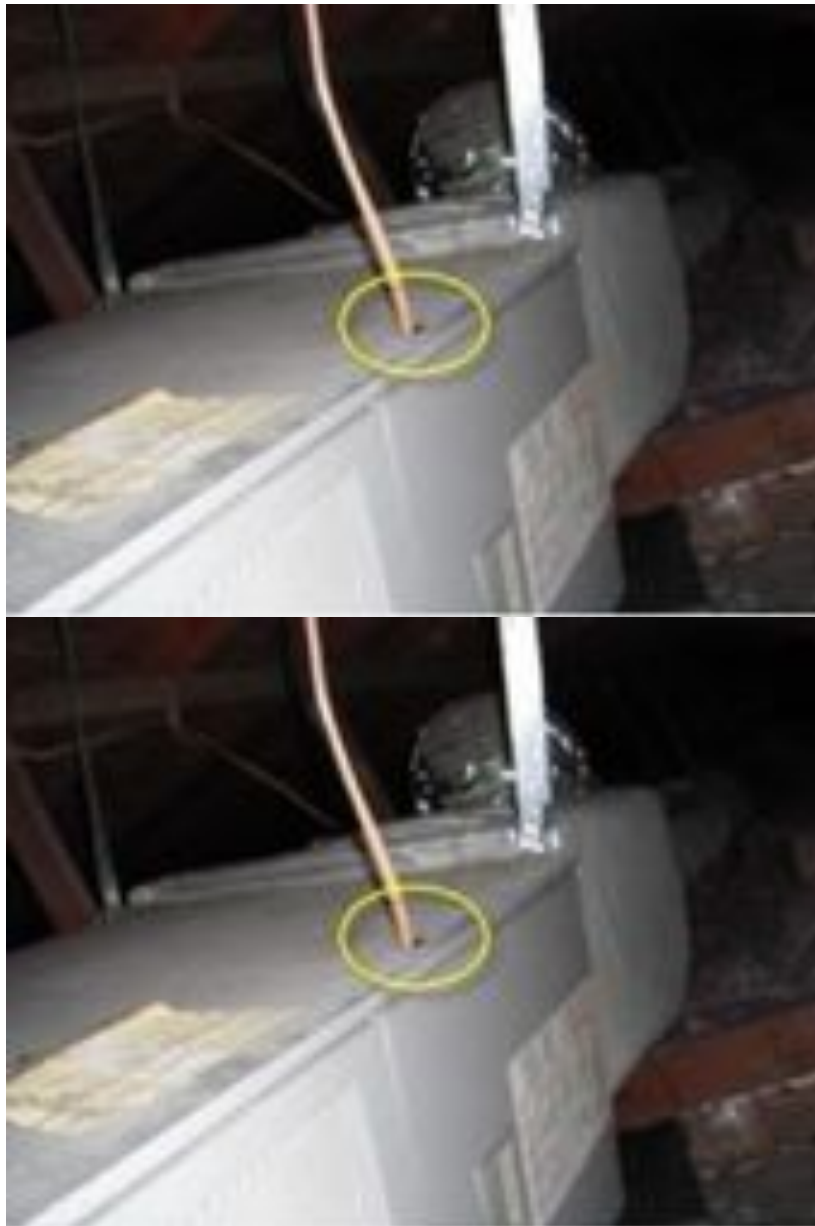
ROMEX cables must be protected from the metal cabinet with a grommet; abrasion can lead to the insulation being cut

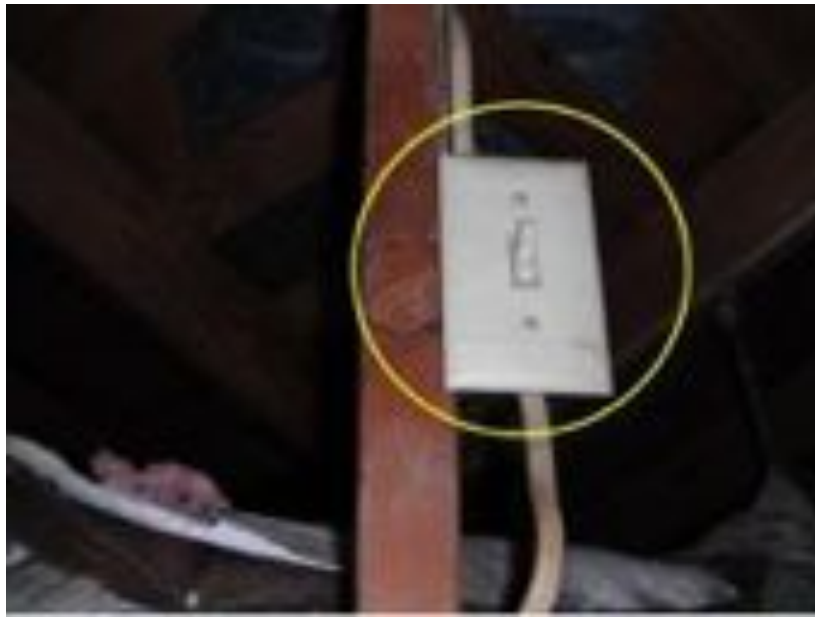
Only metal covers should be used on switch boxes, junction boxes and outlets in an attic

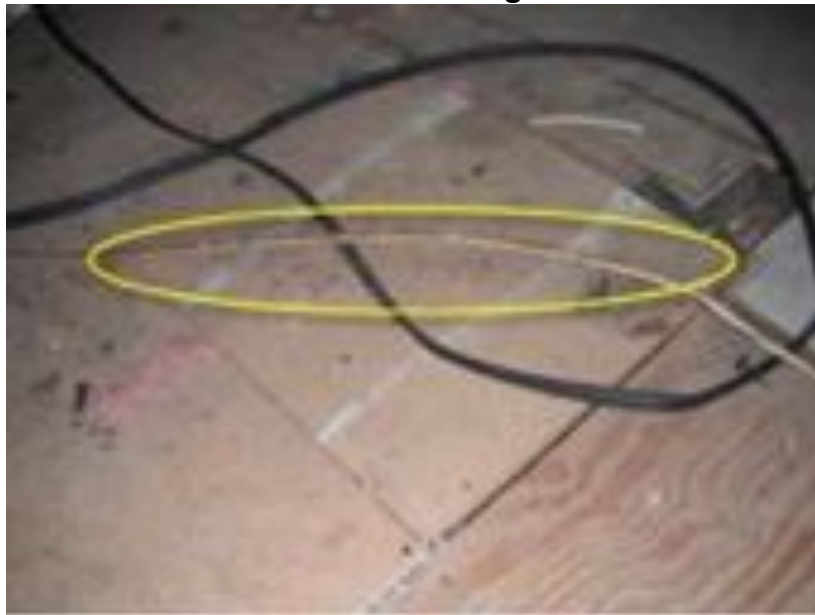
Protect all ROMEX cables running over service boards

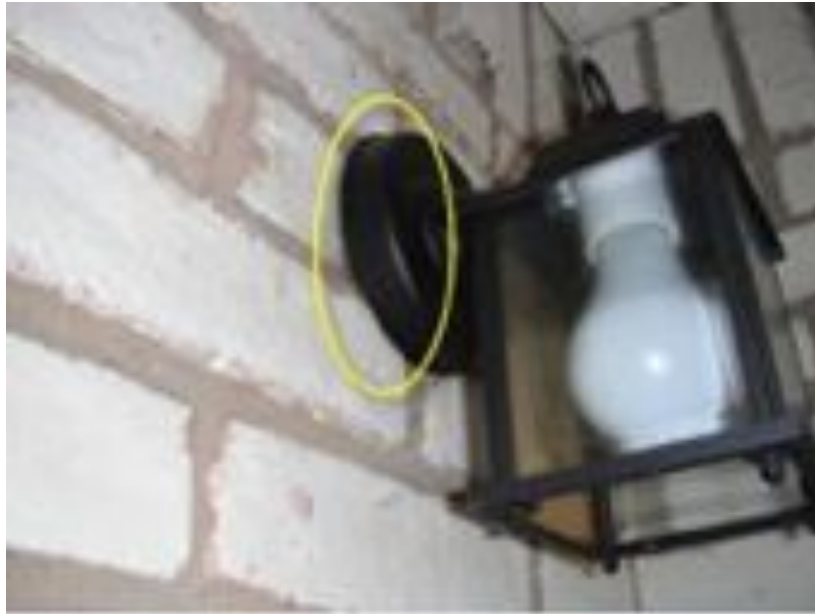
Caulk around light and wall to prevent water penetration

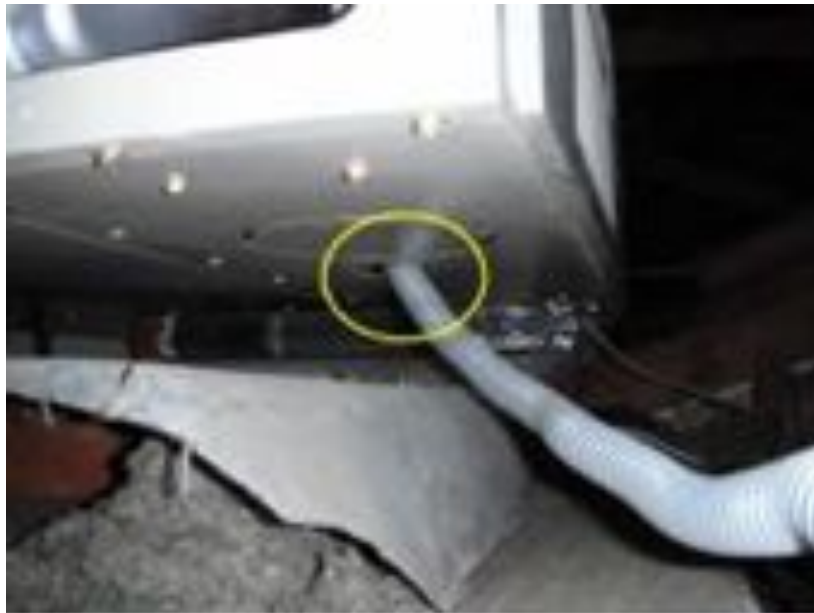
Only steel pipe should be used here, the metal cabinet can cut the flexible gas line leading tpo a gas leak and possible fire.

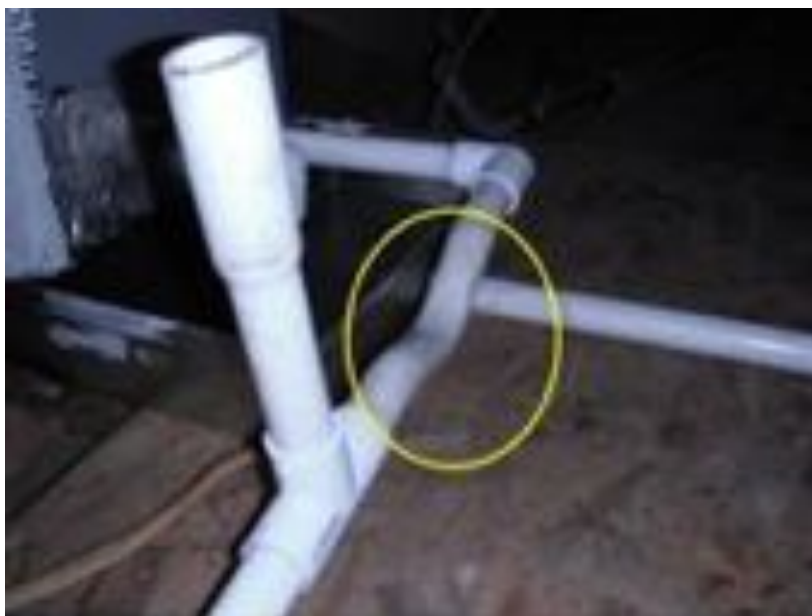
Insulate P trap on drain line

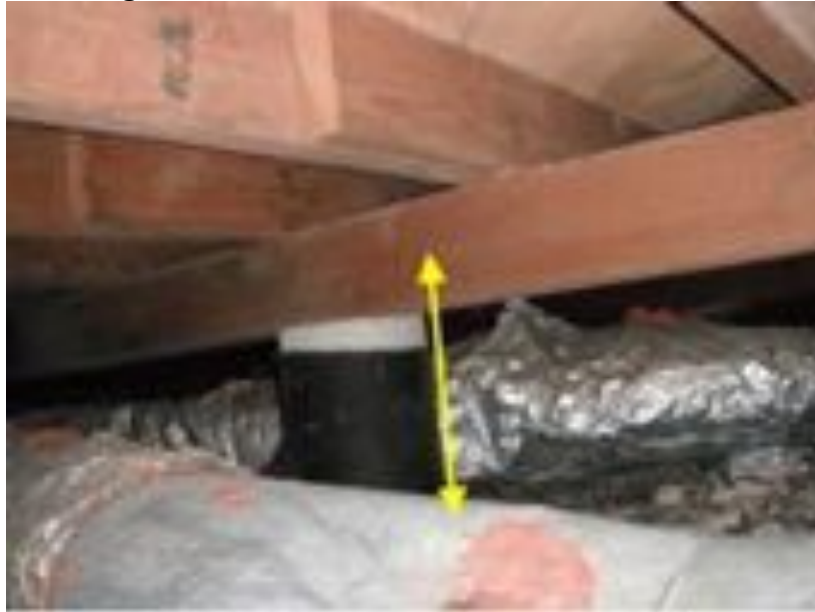
The ducting should be suspended from floor beams and not laying on the ground.

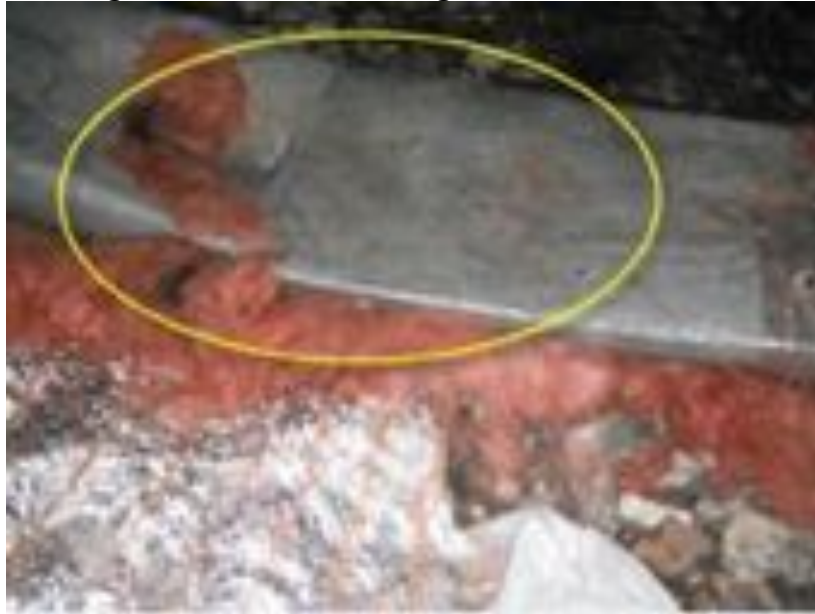
Ducting crushed and missing insulation in the crawl space

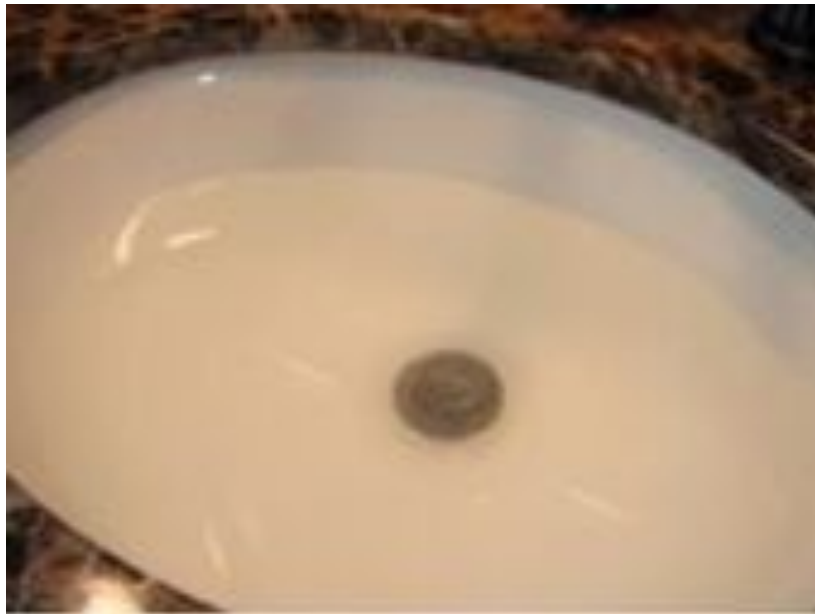
Caulk faucet to prevent water penetration into wall

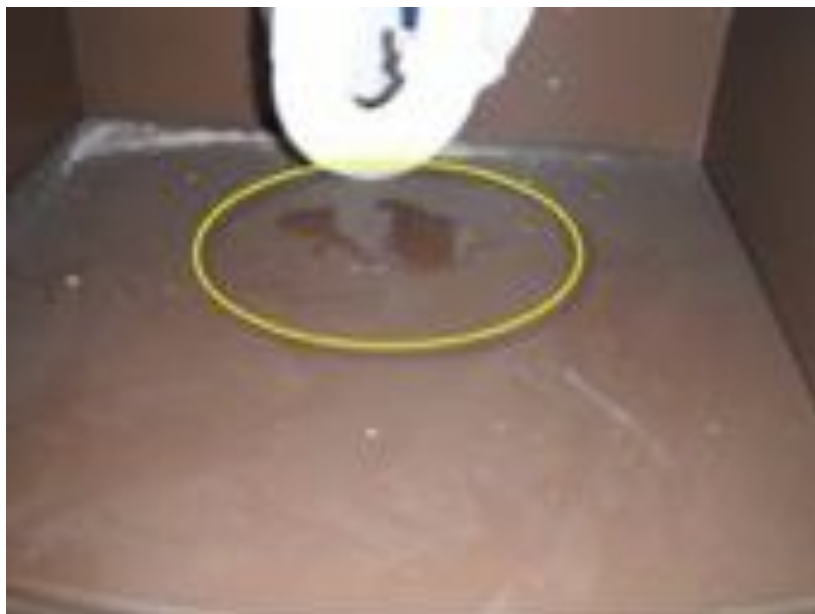
Leak at master bathroom vanity

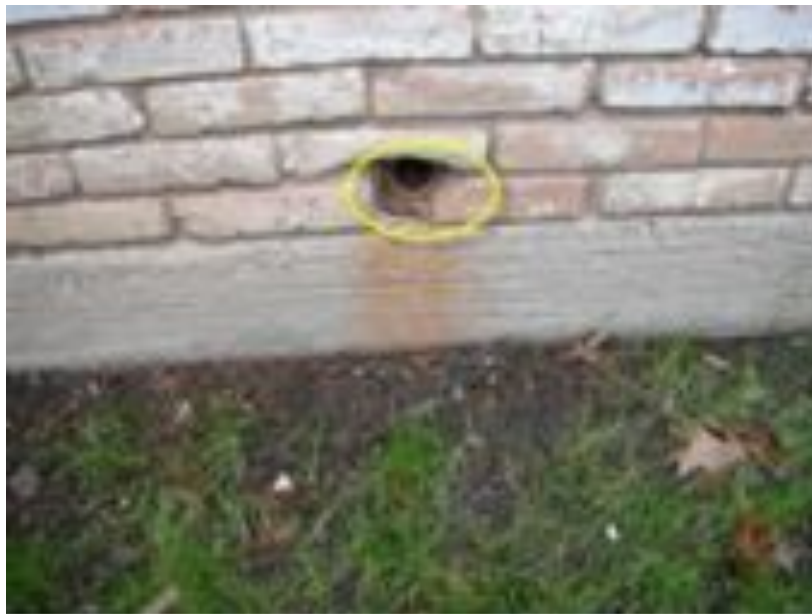
Seal clear out at the left elevation

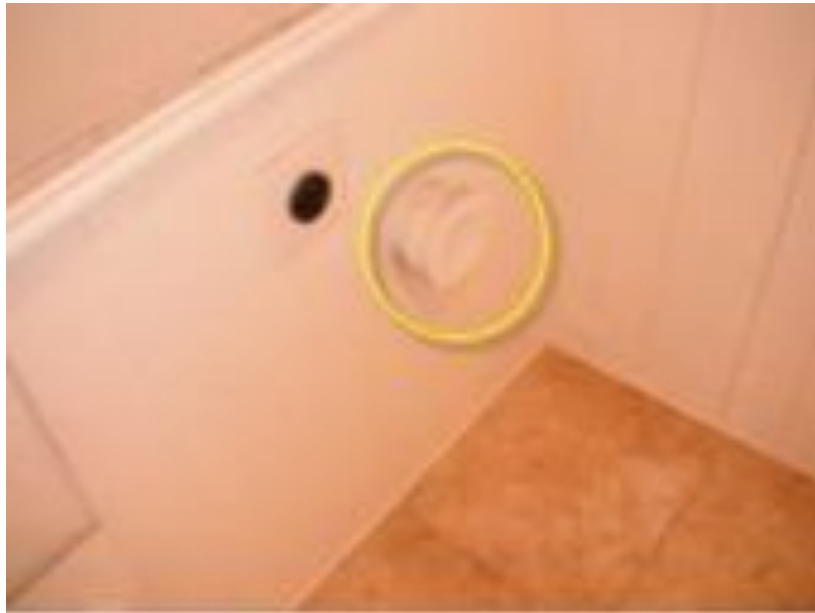
The dryer should not vent into the garage, lint is a fire hazard and can auto combust leading to a dangerous combination of gasoline and lint fire
