Property Management Inspection Services PMIS Protection with Professional Documentation.

Inspector: Charles Barnes

St. Address: 217 Oak Knoll Circle

City: Boerne

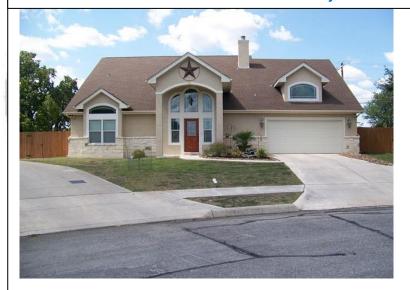
Picture 1 Street View of Home to Include Driveway/Sidewalks

Exterior Comments: Location was absent of any address markings(see#2). Tenant commented that sprinkler system ceased operation appr. 2 months prior to inspection. Requires further inspection. Right rear fenceline is in need of replacement slats due to broken/missing slats(see#71,72). Tripping hazard in front yard from protruding water pipe towards sidewalk(see#1,67).

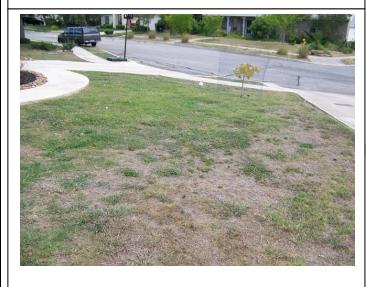
Picture #69

Comments: Front and rear yards could use further attention due to extreme dryness(see#69). Front door faded/worn from sun and in need of weatherstripping(see#70,76). Right rear fenceline in need of replacement slats(see#71,72).

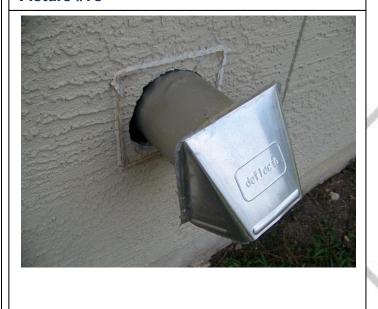
Picture #73

Comments: Dryer vent pushed away from wall exposing hole(see#73). Left rear corner cracked on bottom(see#74). Hairline crack on rear patio in front of door(see#75). Weatherstripping exposing light gap on front door(see#76).

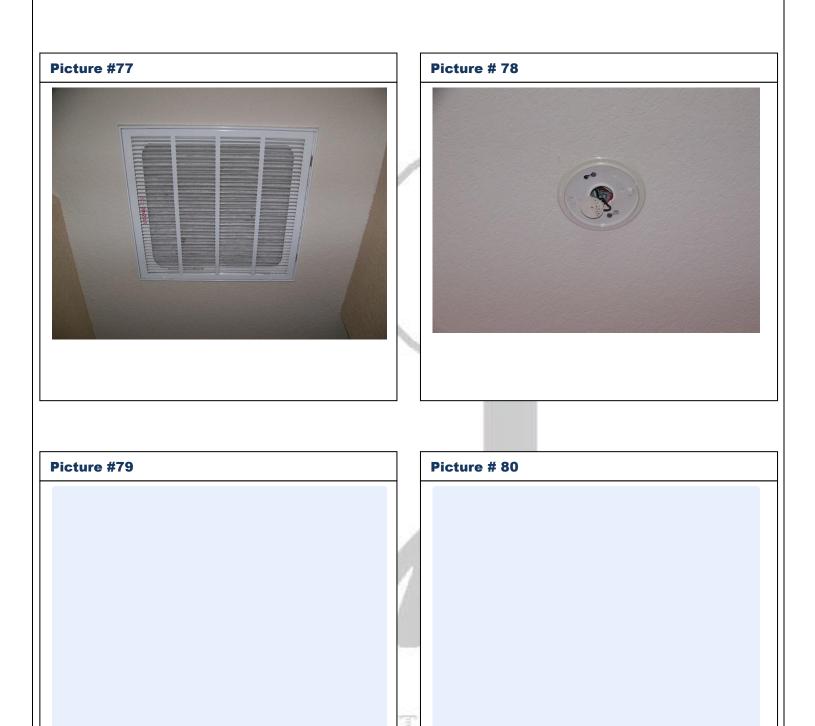
Comments: A/C filters in need of replacement(see#77). Smoke alarm disconnected due to malfunction in 2nd Bedroom(see#78).
