## **Architectural Analysis of 226, Allensworth St.**

*By: Architectural Historian  
Shelley Roff, PhD*

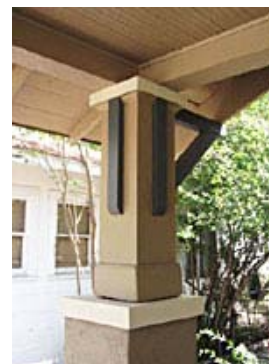
226 Allensworth has been beautifully restored by its owner. A shaded porch recedes under the cross-gabled roof in shades of soft taupe, white and hints of a dark slate blue. The roof eaves are supported by brick piers, each with a wood, square column and chunky, wood eave bracket. Some of the structural members of the roof are still exposed, as they would have been in the original house. The addition of the battered skirt surrounding base of the house was a romantic feature alluding to the battered walls of old medieval fortifications, admired by Craftsman Style designers. The slope of these walls gives a greater visual weight and feeling of stability to the house. The long, horizontal lines of the wood siding further enhance the low profile.

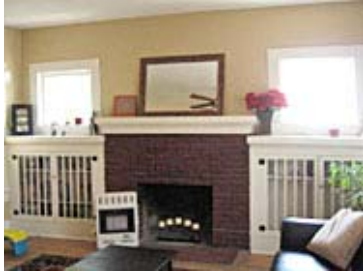
weight-and-pulley square windows to illuminate the space. The bookshelf doors, as well as other doors in

the house still retain the original bronze butterfly hinges, now painted over.

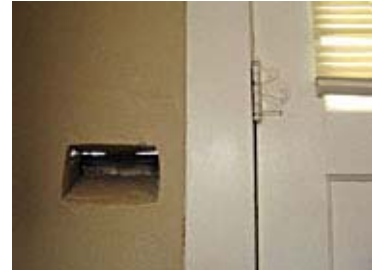
The Craftsman bungalow interior typically included a high wainscot to insulate the walls, whose lines were integrated with the door and

window frames. Although this detail is not present in the public spaces of this house, the owner has replicated a board and batten wainscot in the bathroom that is appropriate to its 1925 black and white hexagonal floor tile.
