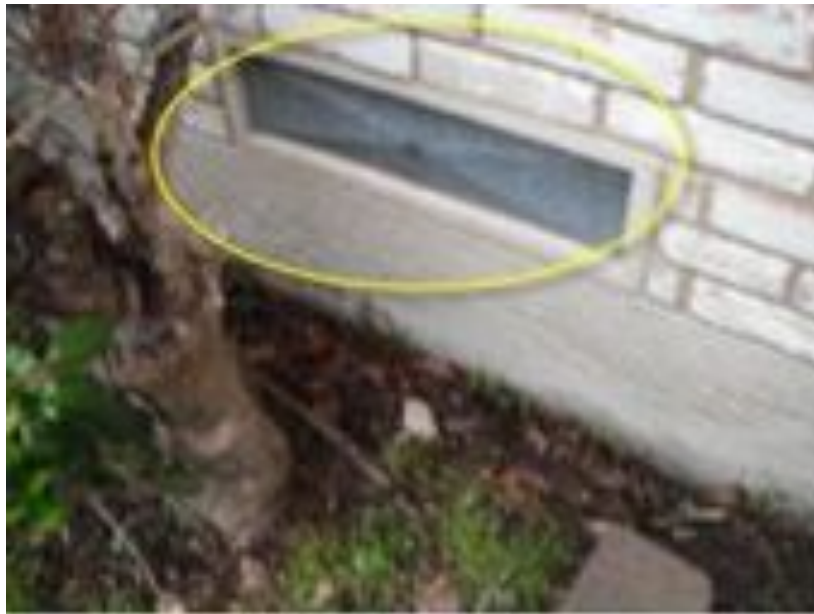
There are cracks or un-square openings within and around the residence that are indicative of movement and which could be attributable to common settling.

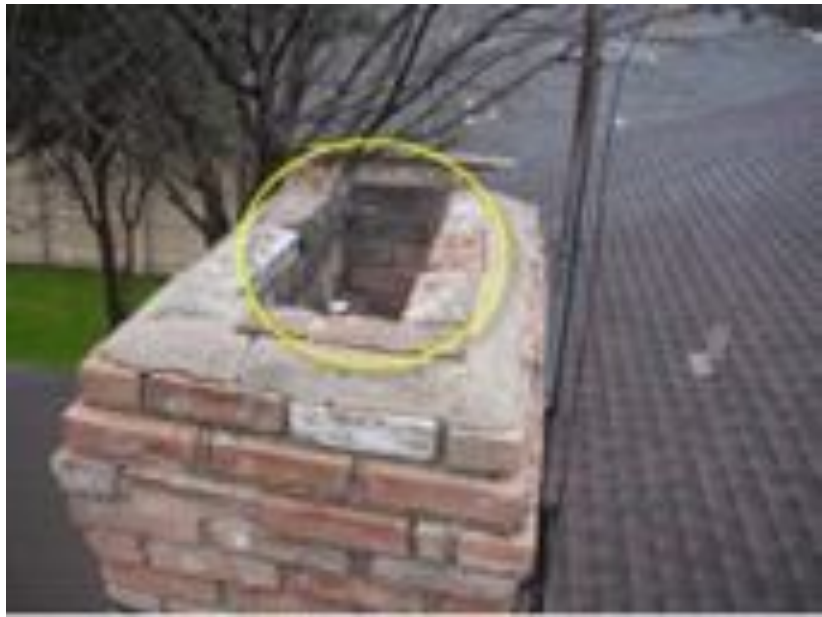
- Combustion air vent present.
- Combustion air vent not present.
- Gas valve/logs present
- No damper block present as required by current standards for units equipped with gas logs
- Gas valve/logs not present.
- Deficiencies in the visible components and structure of the chimney and fireplace.
- Deficiencies in the firebox and visible flue area.
- Built-up creosote in visible areas of the firebox and flue.**

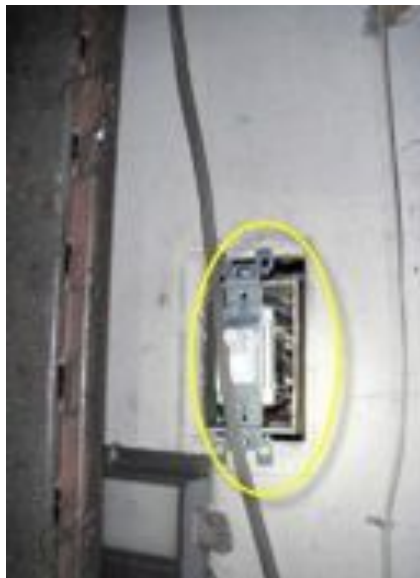
Ground fault circuit interrupter devices are not properly installed as set forth by the current edition of the National Electric Code, publication 70A of the National Fire Protection Association.
