Property Management Inspection Services PMIS Protection with Professional Documentation.

Inspector: Charles Barnes

St. Address: 217 Oak Knoll Circle

City: Boerne

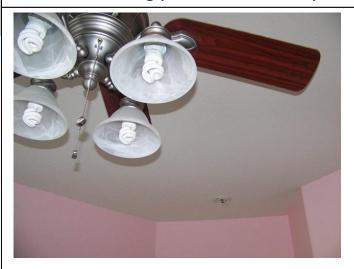
Picture # 46 Ceiling (Fan/Smoke Detector)

Interior Comments: Tenant commented that upstairs Game Room was unusually warm. Mentioned warm air coming from elec. outlets & cable outlets. Inspector heard rattling coming from air duct. Tenant thought possible duct disconnection in attic had occurred. Requires further inspection. 2nd Bedroom has disconnected smoke alarm due to malfunction. Tenant commented replacement batteries did not provide solution. Requires further inspection.

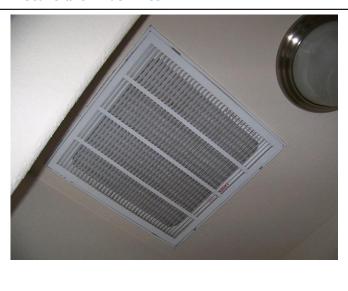
Picture # 64 A/C Filter

Comments: A/C filters in need of replacement(see#77). Smoke alarm disconnected due to malfunction in 2nd Bedroom(see#78).
