Architectural Analysis of 504, E. Mulberry Avenue

By: *Architectural Historian*
Shelley Roff, PhD

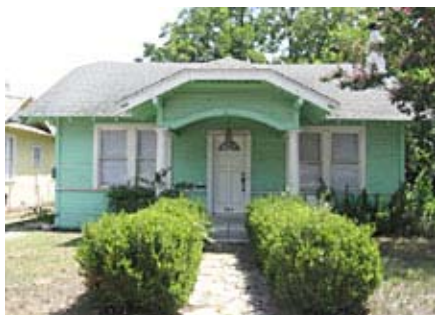
This sweet little bungalow on 504 Mulberry, near Trinity University, was once owned by two women, possibly sisters or spinsters, who owned the house for most of its life. Built in 1937, on the tail end of the Depression Era, it lacks some signature details of a true Craftsman bungalow, however the arrangement of its plan, a few interior details, and its roof demonstrate the design of an architect who was very familiar with the Arts and Crafts Style.

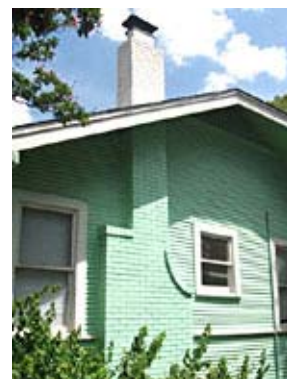
A prominent portico extends from the center of the front façade, and pairs of windows are arranged symmetrically to each side. The house's most dramatic characteristic is the shape of the roof, a half-hip, and the miniaturized version echoed in the smaller roof sheltering the entry portico. The half-hip roof is essentially a gabled roof, but the end point of the gable is replaced by a small hip (a fold). This style of roof came in vogue in the U.S. in the early 20th century, when designers of the Arts and Crafts movement were intrigued with Japanese design. Americans first direct contact with Japanese design came about with the construction of several Japanese pavilions at the Philadelphia Centennial in 1876 and the World's Columbian Exposition in Chicago in 1893. The exquisite craftsmanship and clean-cut forms of these buildings drew tremendous attention, and the practicality of the deeply extended eaves of both gabled and half-hip roofs were quickly understood.

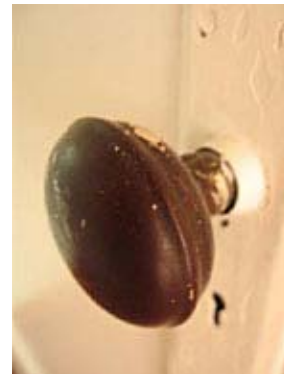
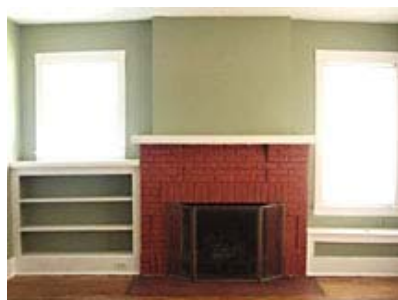
The chimney on the west side of the house has a whimsical curve, as seen in other bungalows nearby, and literally punctuates the roofline. Looking once more at the entry to the house, the classical columns, and definitely the front door, are later additions, not in keeping with Arts and Crafts decor. However, the interior arrangement of the living room is almost classic. A central fireplace with a shifting pattern of bricks is flanked on each side by a double-hung window with a bookcase and a window seat below. The square-shaped window to the left is more traditional; indicating that perhaps the window seat and longer window design to the right may be a later renovation.

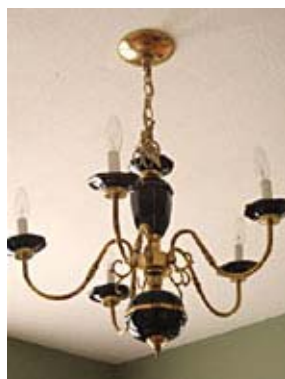
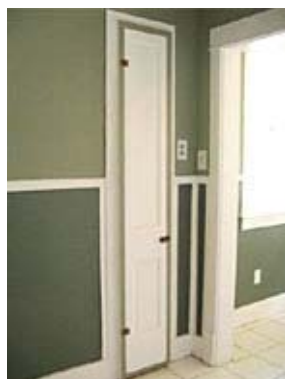
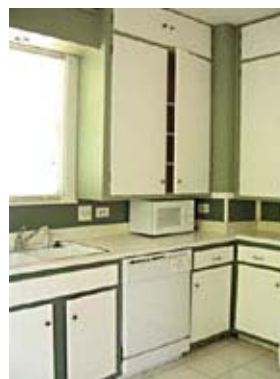
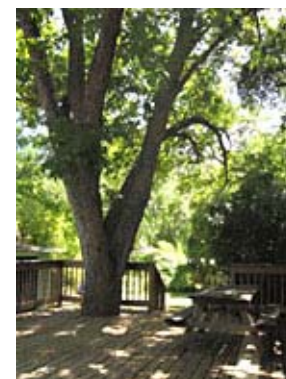
The kitchen retains its original cabinetry but has been updated with modern appliances. The cabinetry, walls and trim have been painted in beautiful shades of green and white that highlight the outline of the former wall's wainscoting. The built-in ironing board niche has now been turned into an enclosed space for shallow shelves. Other details worthy of note throughout the house are the extensive window and door moldings and the numerous versions of cut-glass and bronze door knobs and hinges, all original to the construction of the house. The shiny black and gold chandelier in the dining room is probably an addition from the 1970s.
