## Architectural Analysis of 209, Ira Avenue

By: *Architectural Historian*  
Shelley Roff, PhD

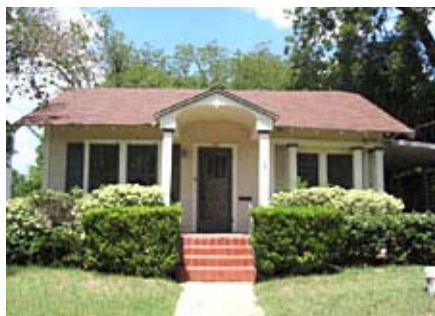
The house on 209 Ira Avenue in Mahncke Park is a nicely restored and updated 1920s bungalow. The long axis of the gabled roof faces the street, and exposed rafters, tucked neatly under the roof line, give an initial indication of its Craftsman inspiration. The design of the front façade, with a central entrance portico and symmetrical pairs of windows to each side, is one commonly seen in the neighborhoods just north of downtown.

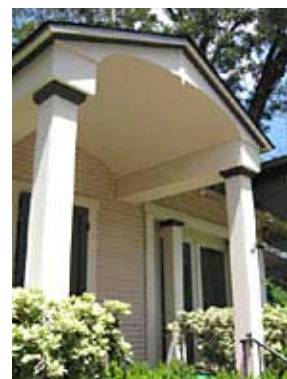
However, notice the extra columns in front of the windows to the right. It appears that the right side of the house was once an exterior porch. An asymmetrical porch and side entry, tucked under the major roofline of the house, is a hallmark of American bungalow design. It was simply more economical to construct a rectangular foundation and allow the porch and entry to reside within this boundary. This leads me to believe that the attached entry portico in the center, although charming, was not part of the early design of the house. The original entry to the house would have been through a door off the porch, on the east wall, which is now simply a large framed opening between the living and sunroom areas.

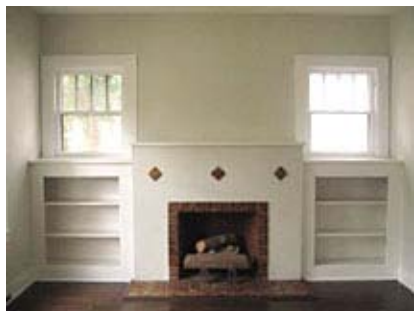
asymmetrical, rectangular glass panels that mimic a pattern in Craftsman design: the large rectangles of wood paneling typically used as an inexpensive means to ornament walls. The wood siding of the ceiling is a reminder of this room's former function as the exterior porch.

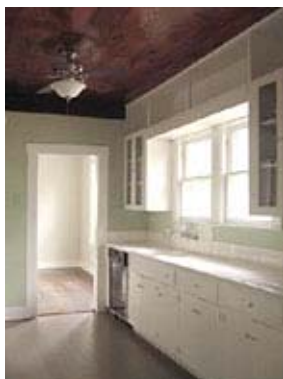
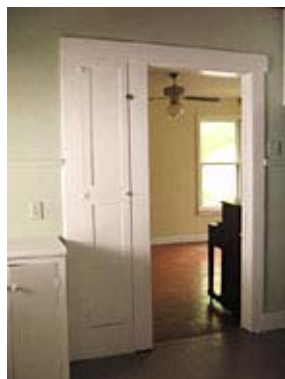
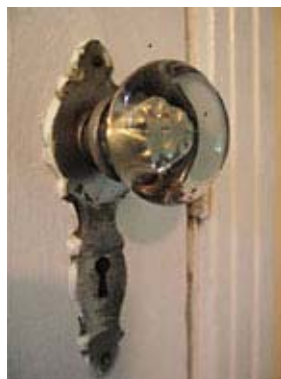
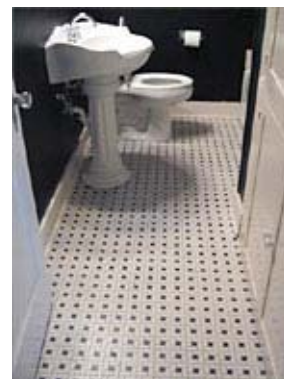
The darkly stained oak floor of the living and dining room extends into the large, sun-filled kitchen. The pine ceiling has a dark stain to match and the walls are painted, in contrast, with a beautiful, creamy "green tea latte" color. The original white, painted wood cabinets are updated with white tile countertops and modern appliances. The bedrooms wrap around the back of the house in soft shades of buttermilk yellow. All of the original wood trim and molding is intact: white, painted base boards, wood molding, multi-paned windows and multi-panel doors. The doors even have their original cut glass doorknobs, and the bathrooms retain their quintessential 1920s hexagonal and black-and-white checkered tile.
